## PC Programming Problem JMX and SST Series Portable Radios

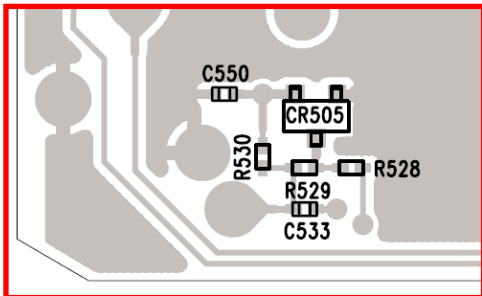
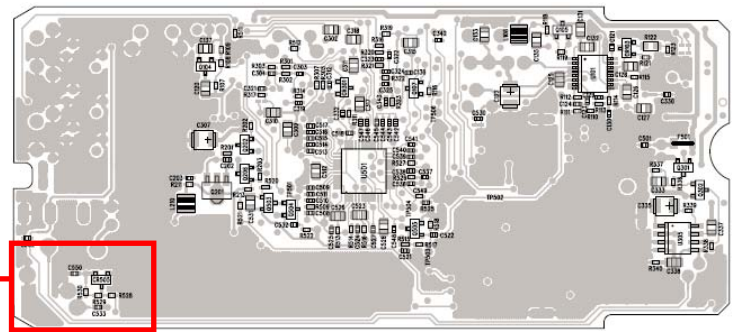
**Models:** JMX-446D, SST-446D  
**PCB:** G1750270M  
**Resistor:** R529  
**Value:** 470 Ohm, 0402 (47180471)

To repair JMX and SST portables with this problem the isolation resistor must be replaced per the following illustrations. Refer to you specific model number and the resistor location will be shown, regardless of PCB revision level. Contact Ritron if your PCB does not appear to be the same as any of these illustrations.

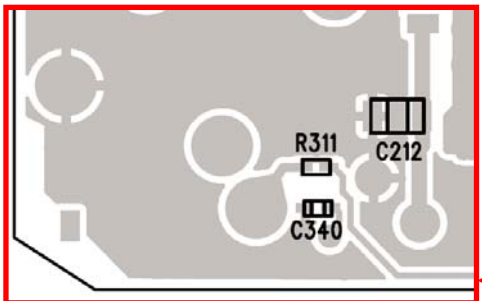
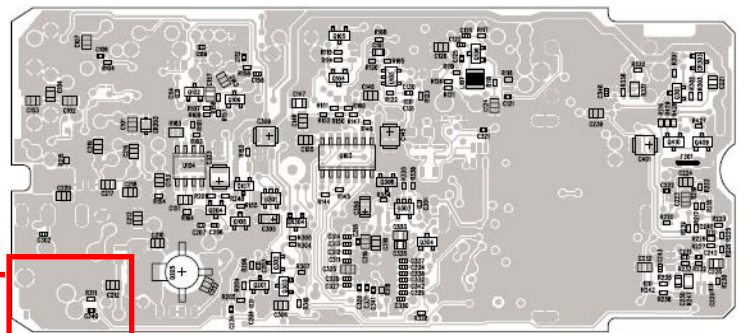
**Models:** JMX-141D, JMX-146D  
**PCB:** G1750350E  
**Resistor:** R311  
**Value:** 270 Ohm, 0402 (47180271)

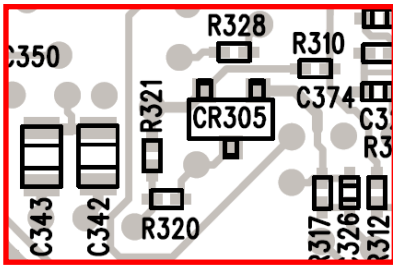
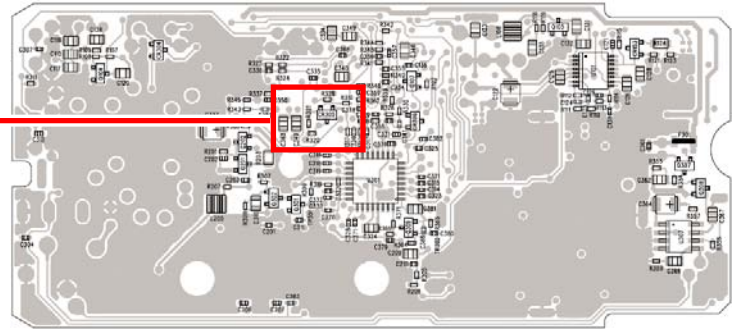
**Models:** JMX-144D, SST-144D  
**PCB:** G1750250J  
**Resistor:** R320  
**Value:** 470 Ohm, 0402 (47180471)

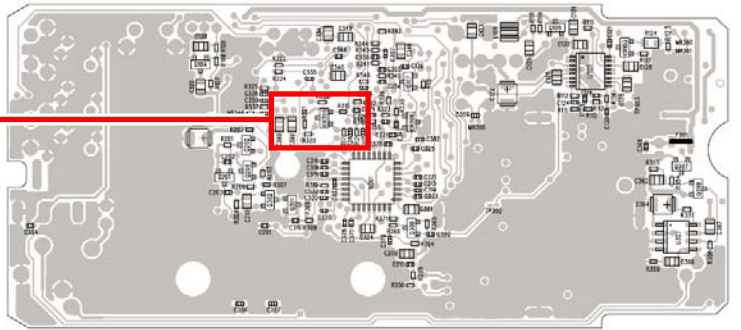
**Models:** JMX-444D, SST-444D  
**PCB:** G1750240J  
**Resistor:** R320  
**Value:** 470 Ohm, 0402 (47180471)

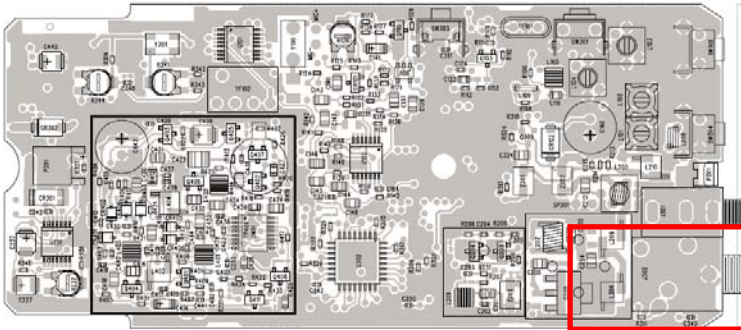
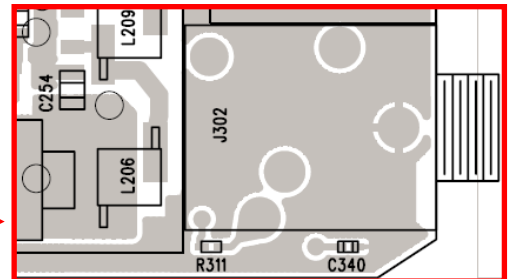
**Models:** JMX-441D  
**PCB:** G1750300K  
**Resistor:** R311  
**Value:** 270 Ohm, 0402 (47180271)
