| Ritron Model(s): | LM-700DMR and RIB-700DMR |
| Current Firmware Revision: | 47.22 |

## LM-700DMR and RIB-700DMR Firmware Revision and Update History

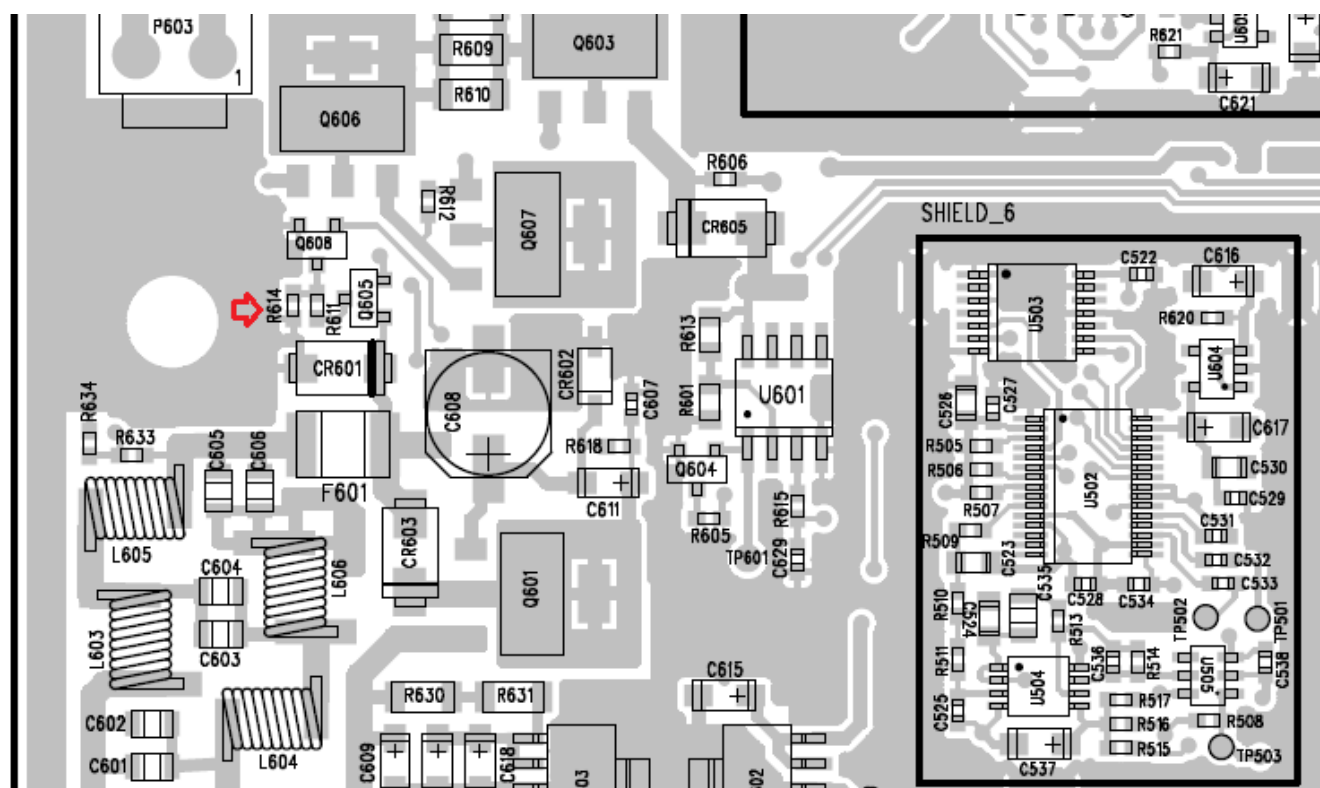
R614 vs. V22/V21

- Added a feature that the unit can auto shutdown when 12V external power is lost and the battery is below 9.5V for at least 5 seconds. Before auto shutdown, the unit will beep 3 times. It is to prevent internal backup battery from over draining. To enable this feature, R614 (0 ohm) has to be removed. R614 was populated on the early units. With V22, if R614 is not removed, the unit will still work like V21, the battery dead auto shutdown just does not work. For the old version firmware, V21 and earlier, if R614 is depopulated, the battery backup function will stop working. i.e. depopulated R614 needs V22 or newer f/w to make the battery backup function work.

| R614 | Depopulated (new built) | Populated (old built) |
|---|---|---|
| F/W V22 and newer | Dead battery auto shutdown (lower than 9.5V) enabled | Dead battery auto shutdown (lower than 9.5V) is disabled, Same as V21 or older |
| F/W V21 and older | Battery backup function will stop working | Dead battery auto shutdown (lower than 9.5V) is disabled |

Updated: Added above R614 part locator on Jul 8, 2025.
