| <b>Ritron Model(s):</b> | LM-700DMR and RIB-700DMR |
| <b>Current Firmware Revision:</b> | <b>47.23</b> |
| <b>Revision Update:</b> | Jul 10, 2025 |

## LM-700DMR and RIB-700DMR Firmware Revision and Update History

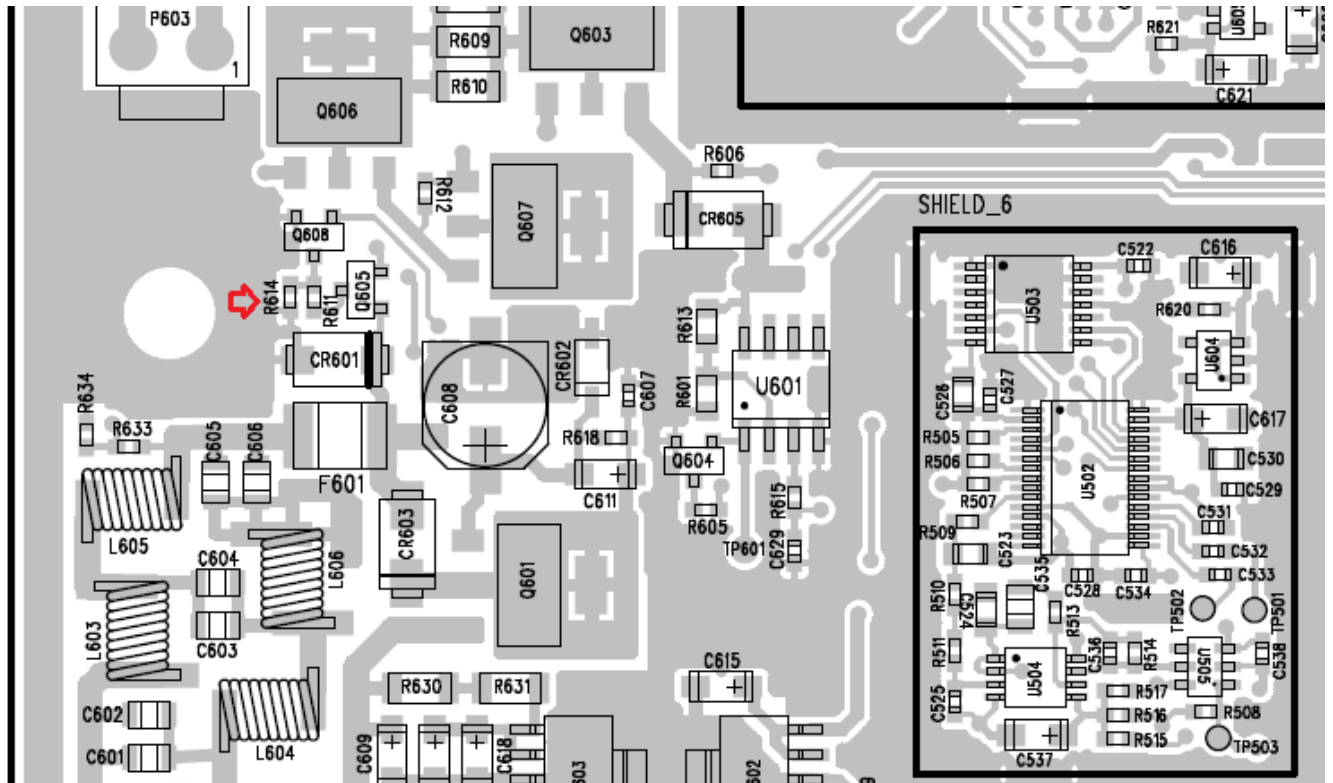
R614 vs. V22/V21

- 1) Added a feature that the unit can auto shutdown when 12V external power is lost and the battery is below 9.5V for at least 5 seconds. Before auto shutdown, the unit will beep 3 times. It is to prevent internal backup battery from over draining. To enable this feature, R614 (0 ohm) has to be removed. R614 was populated on the early units. With V22, if R614 is not removed, the unit will still work like V21, the battery dead auto shutdown just does not work. For the old version firmware, V21 and earlier, if R614 is depopulated, the battery backup function will stop working. i.e. depopulated R614 needs V22 or newer f/w to make the battery backup function work.

| R614 | Depopulated (new built) | Populated (old built) |
| F/W V22 and newer | Dead battery auto shutdown (lower than 9.5V) enabled | Dead battery auto shutdown (lower than 9.5V) is disabled, Same as V21 or older |
| F/W V21 and older | Battery backup function will stop working | Dead battery auto shutdown (lower than 9.5V) is disabled |

Updated: Added above R614 part locator on Jul 8, 2025.
